CREAM RIDGE DAM

NJ 00252

PHASE 1 INSPECTION REPORT NATIONAL DAM SAFETY PROGRAM

79 04 05 060
April, 1979

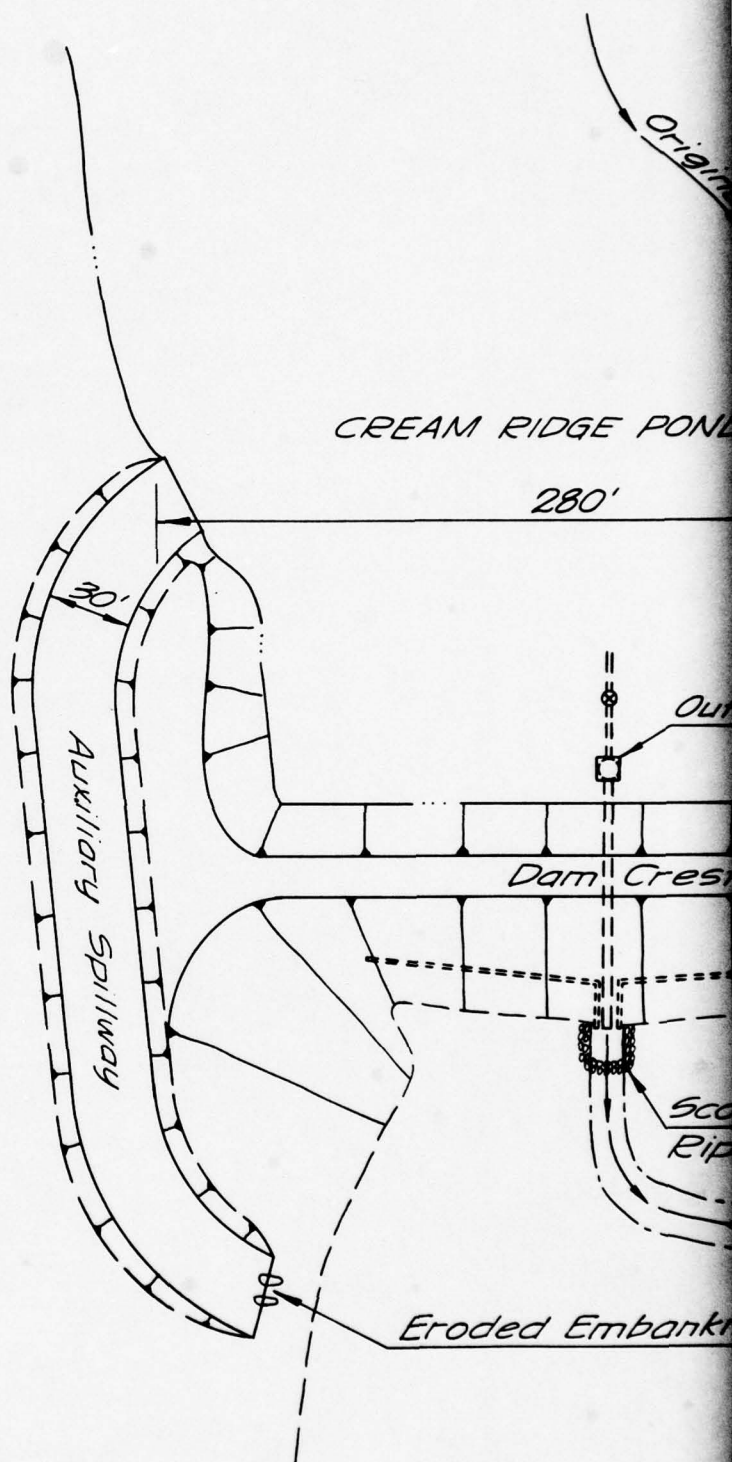
PLATE 4

Two small seepage zones were noted on the south side of the dam during the inspection (see Plate 4 and Photos 8 & 9). The northerlymost zone was located at the interface of the earthfill embankment and the natural embankment. The ground surface in this area was soft and wet at the toe of the downstream embankment slope and up the slope for a height of about 8 feet. This entire area was covered with thick grass.

The upstream portion of the auxiliary spillway was grass lined and in good condition with no signs of erosion. The concrete sill which forms the crest of the auxiliary spillway was grass covered over most of its width and was in good condition. The downstream spillway channel was in good condition down to its outlet where the steep embankment extending down to the natural channel was eroded, (see Plate 4 and Photo 6).

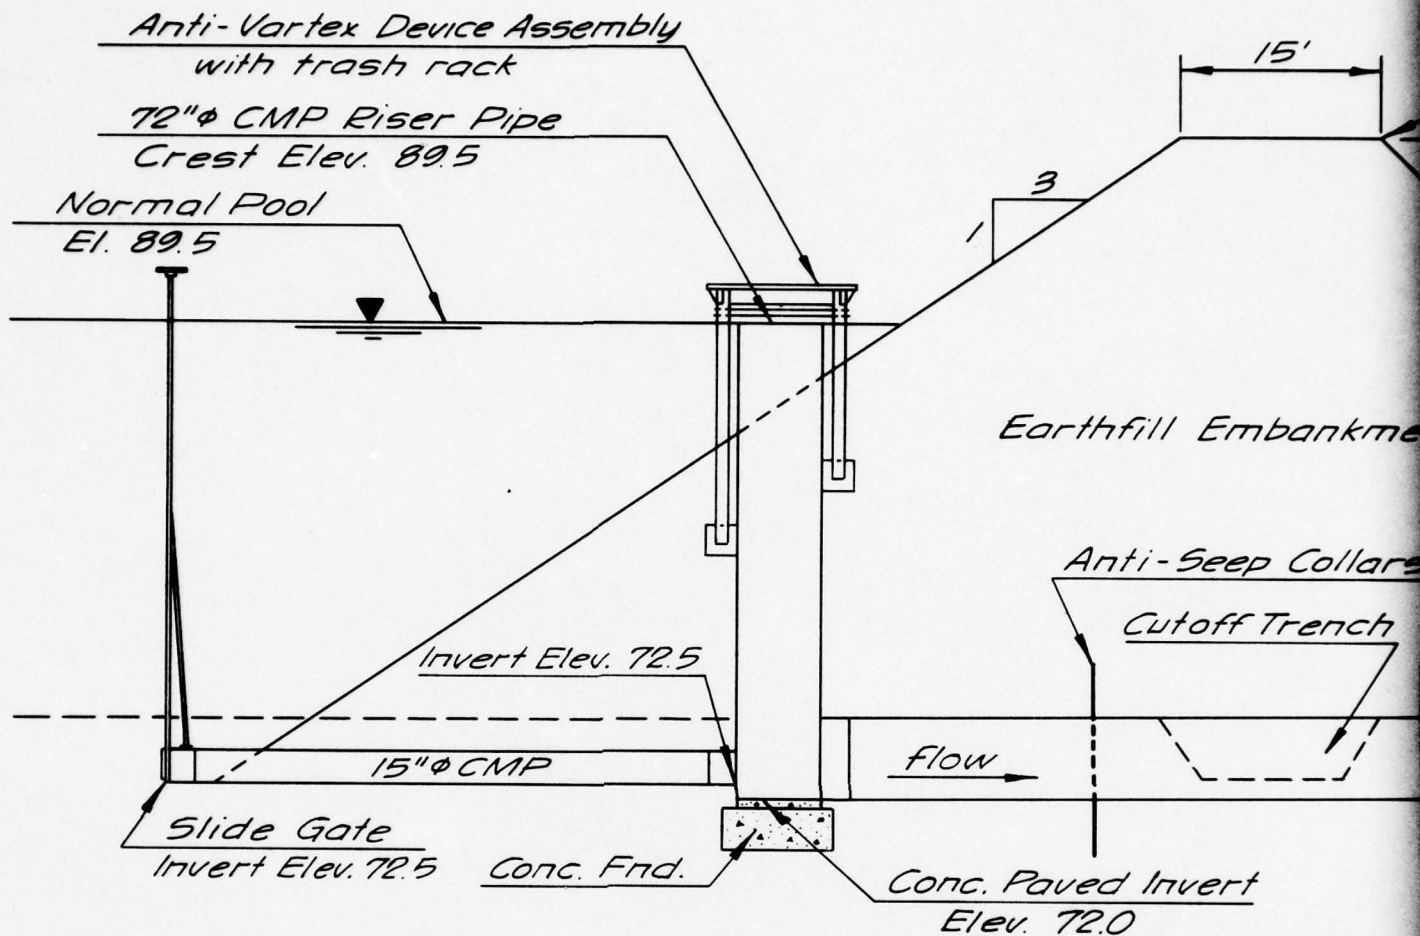
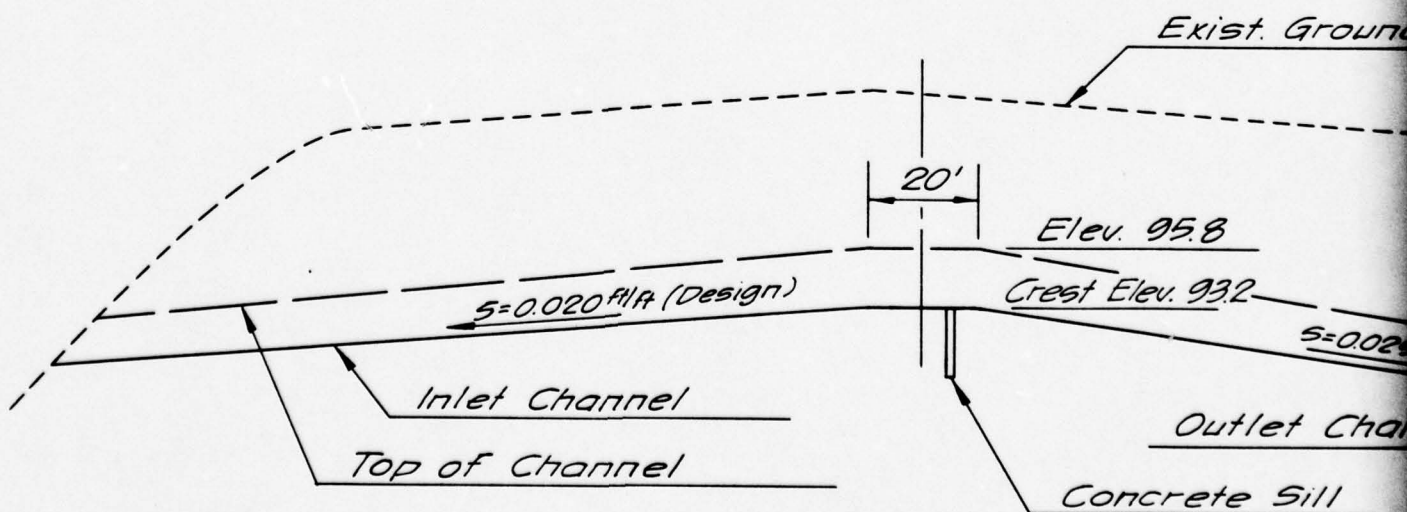
PLATE 5

1. Information taken from "Cross Section of Dam & Spillway" by USDA, Soil Conservation Service and field inspection December 7, 1978.
2. Field inspection indicated that the Rip-rap was scoured.

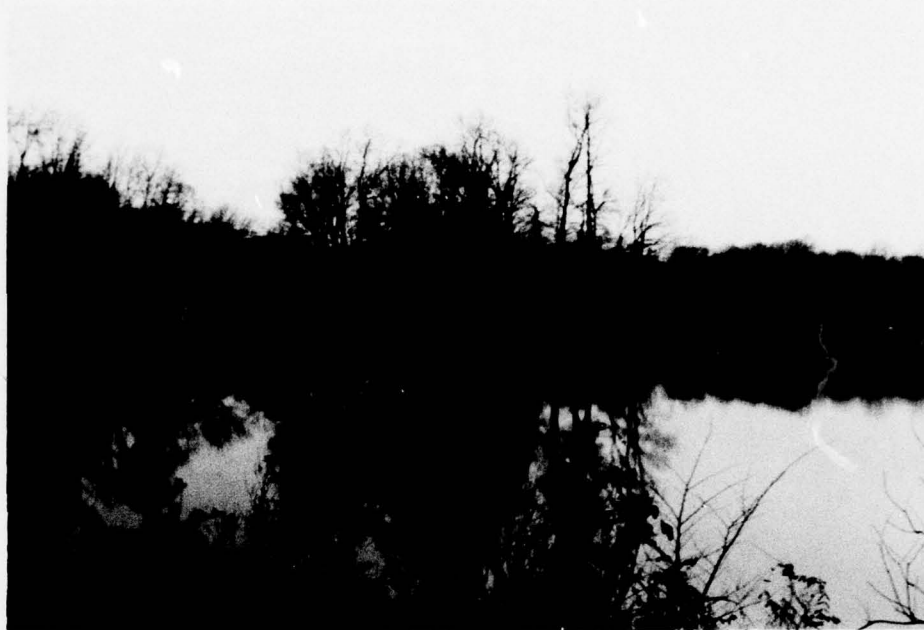
PHOTO 3

The embankment extends north/south and is approximately 280 feet long. The embankment crest at elevation 95.8 (MSL) is 15 feet wide and the sides slope down at 3:1 upstream and 2:1 downstream. The embankment surfaces are covered with a thick stand of grass (see Photos 3 and 4). An earthfill cutoff trench is located along the length of the embankment, approximately at its centerline. A toe drainage trench is located about 15 feet upstream of the downstream embankment toe.

EMBANKMENT - UPSTREAM FACE
